Portage Creek Area Time Critical Removal Action

Progress Update
Public Meeting
5/31/2012

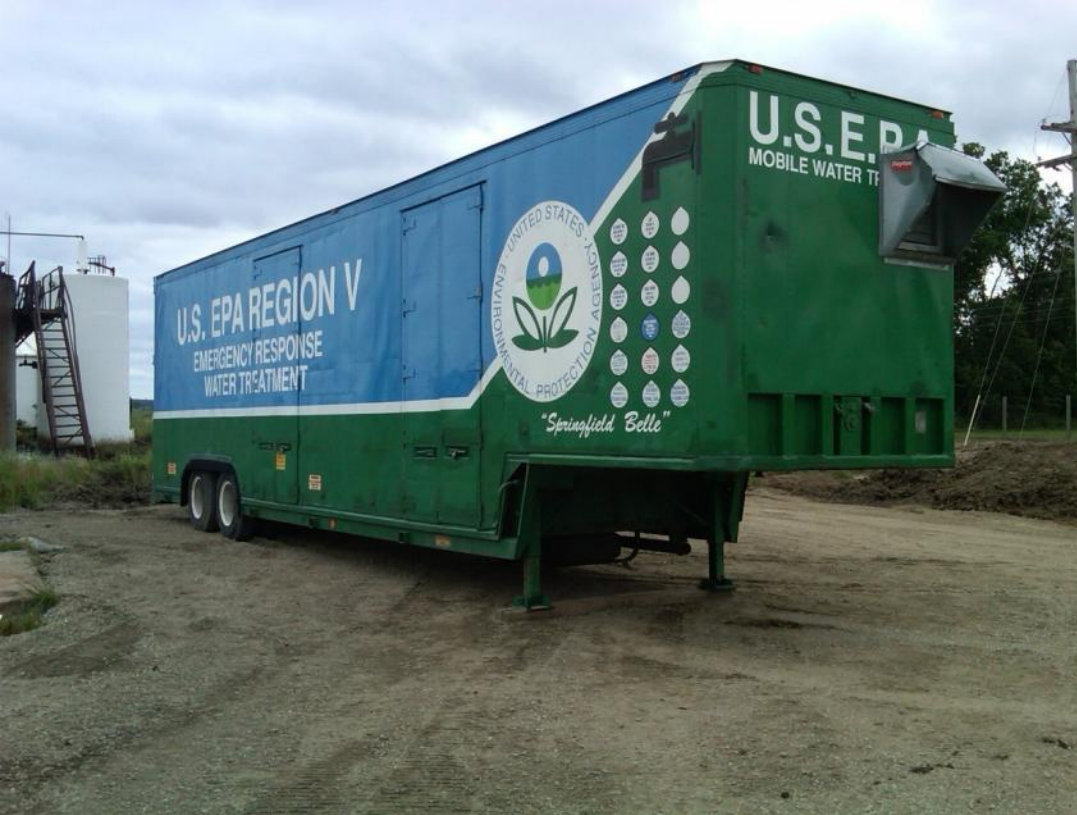
Command Post

Office trailers
De-watering / transfer pad
Equipment Staging
EPA's Mobile Wastewater
Treatment Plant

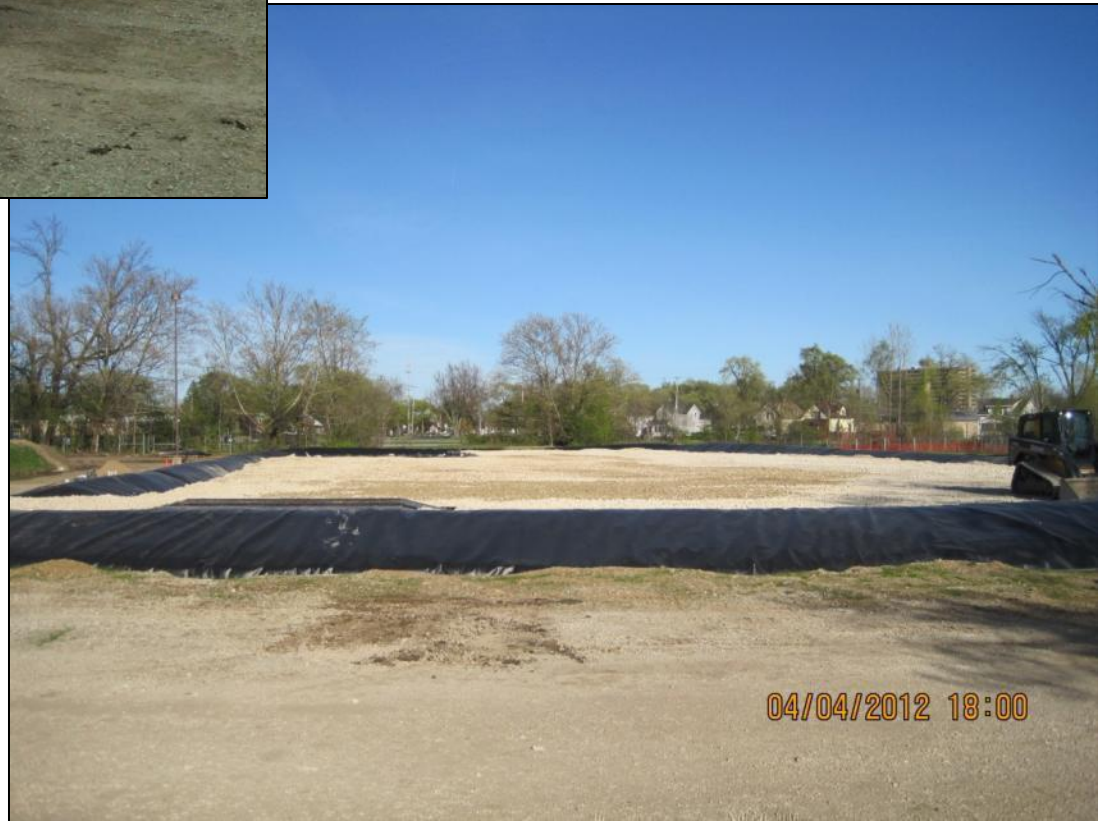
'Springfield Belle' Wastewater Treatment Plant

Staging / De-watering Pad

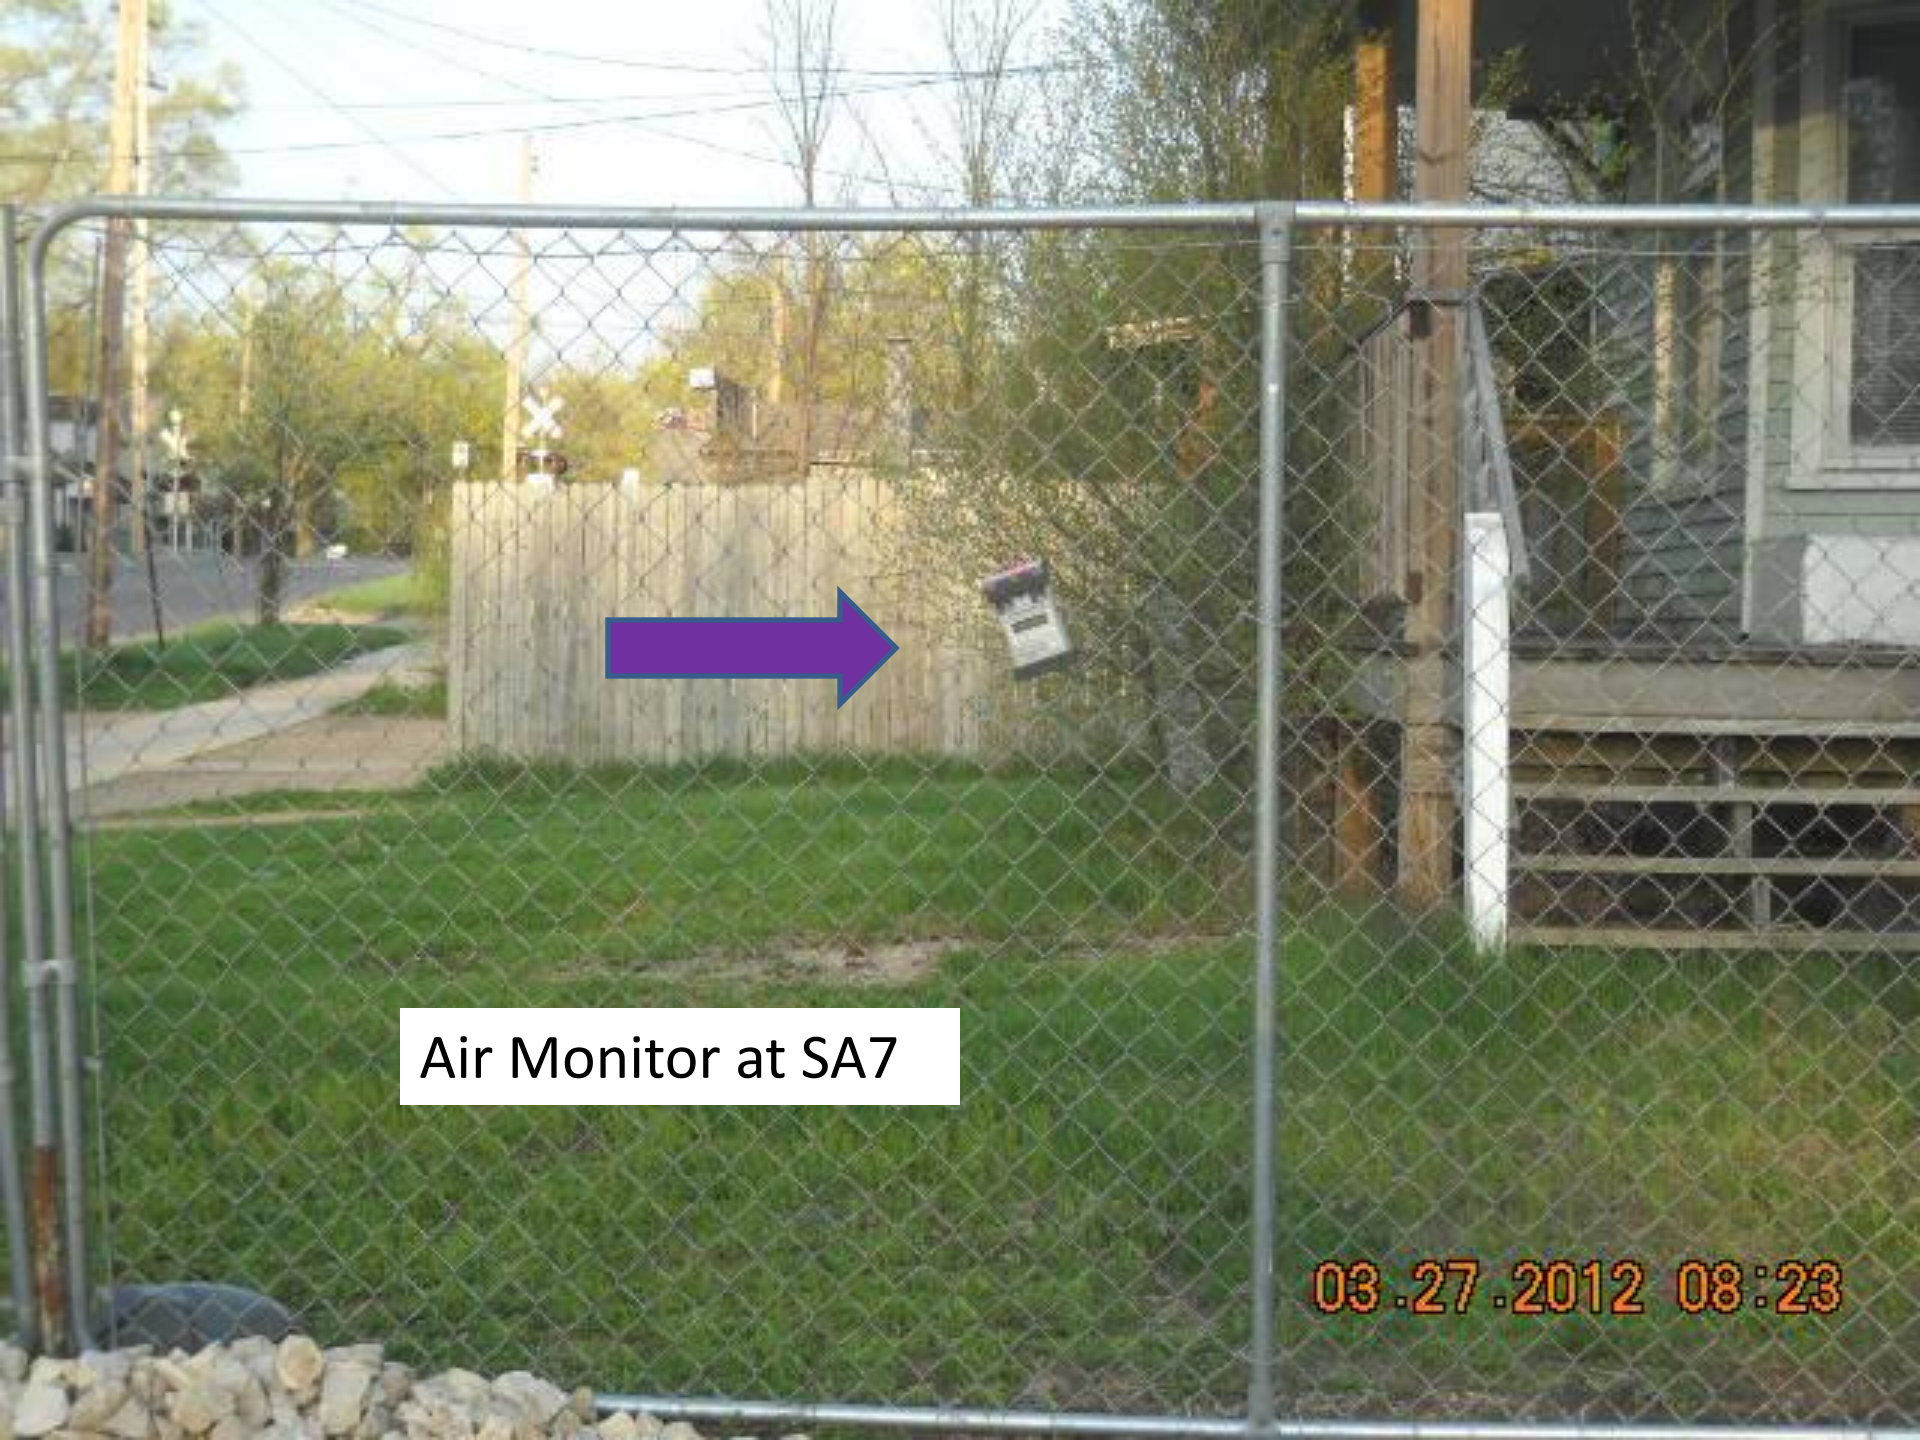
Air Monitor at SA7

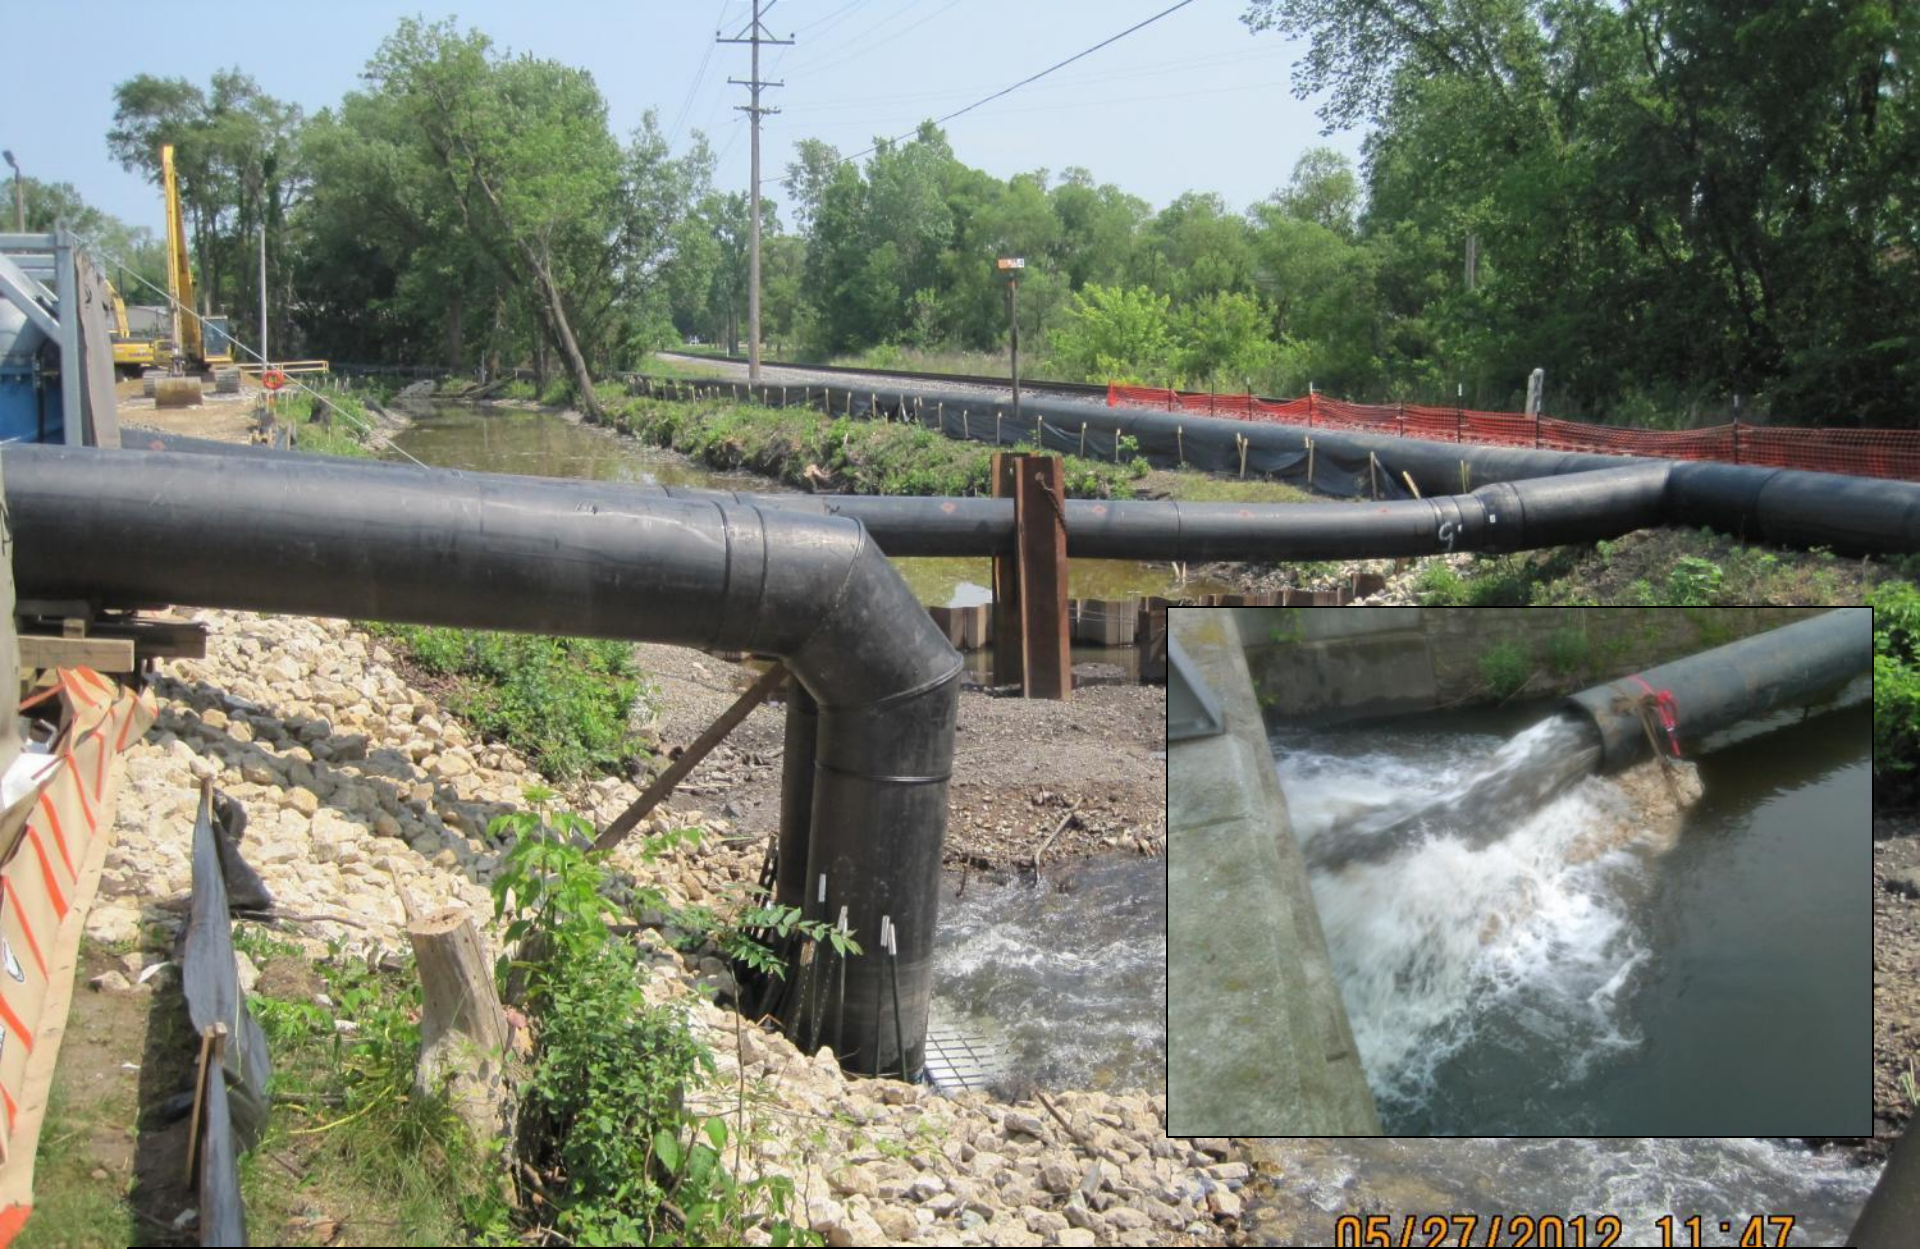
Creek Bypass Pump System

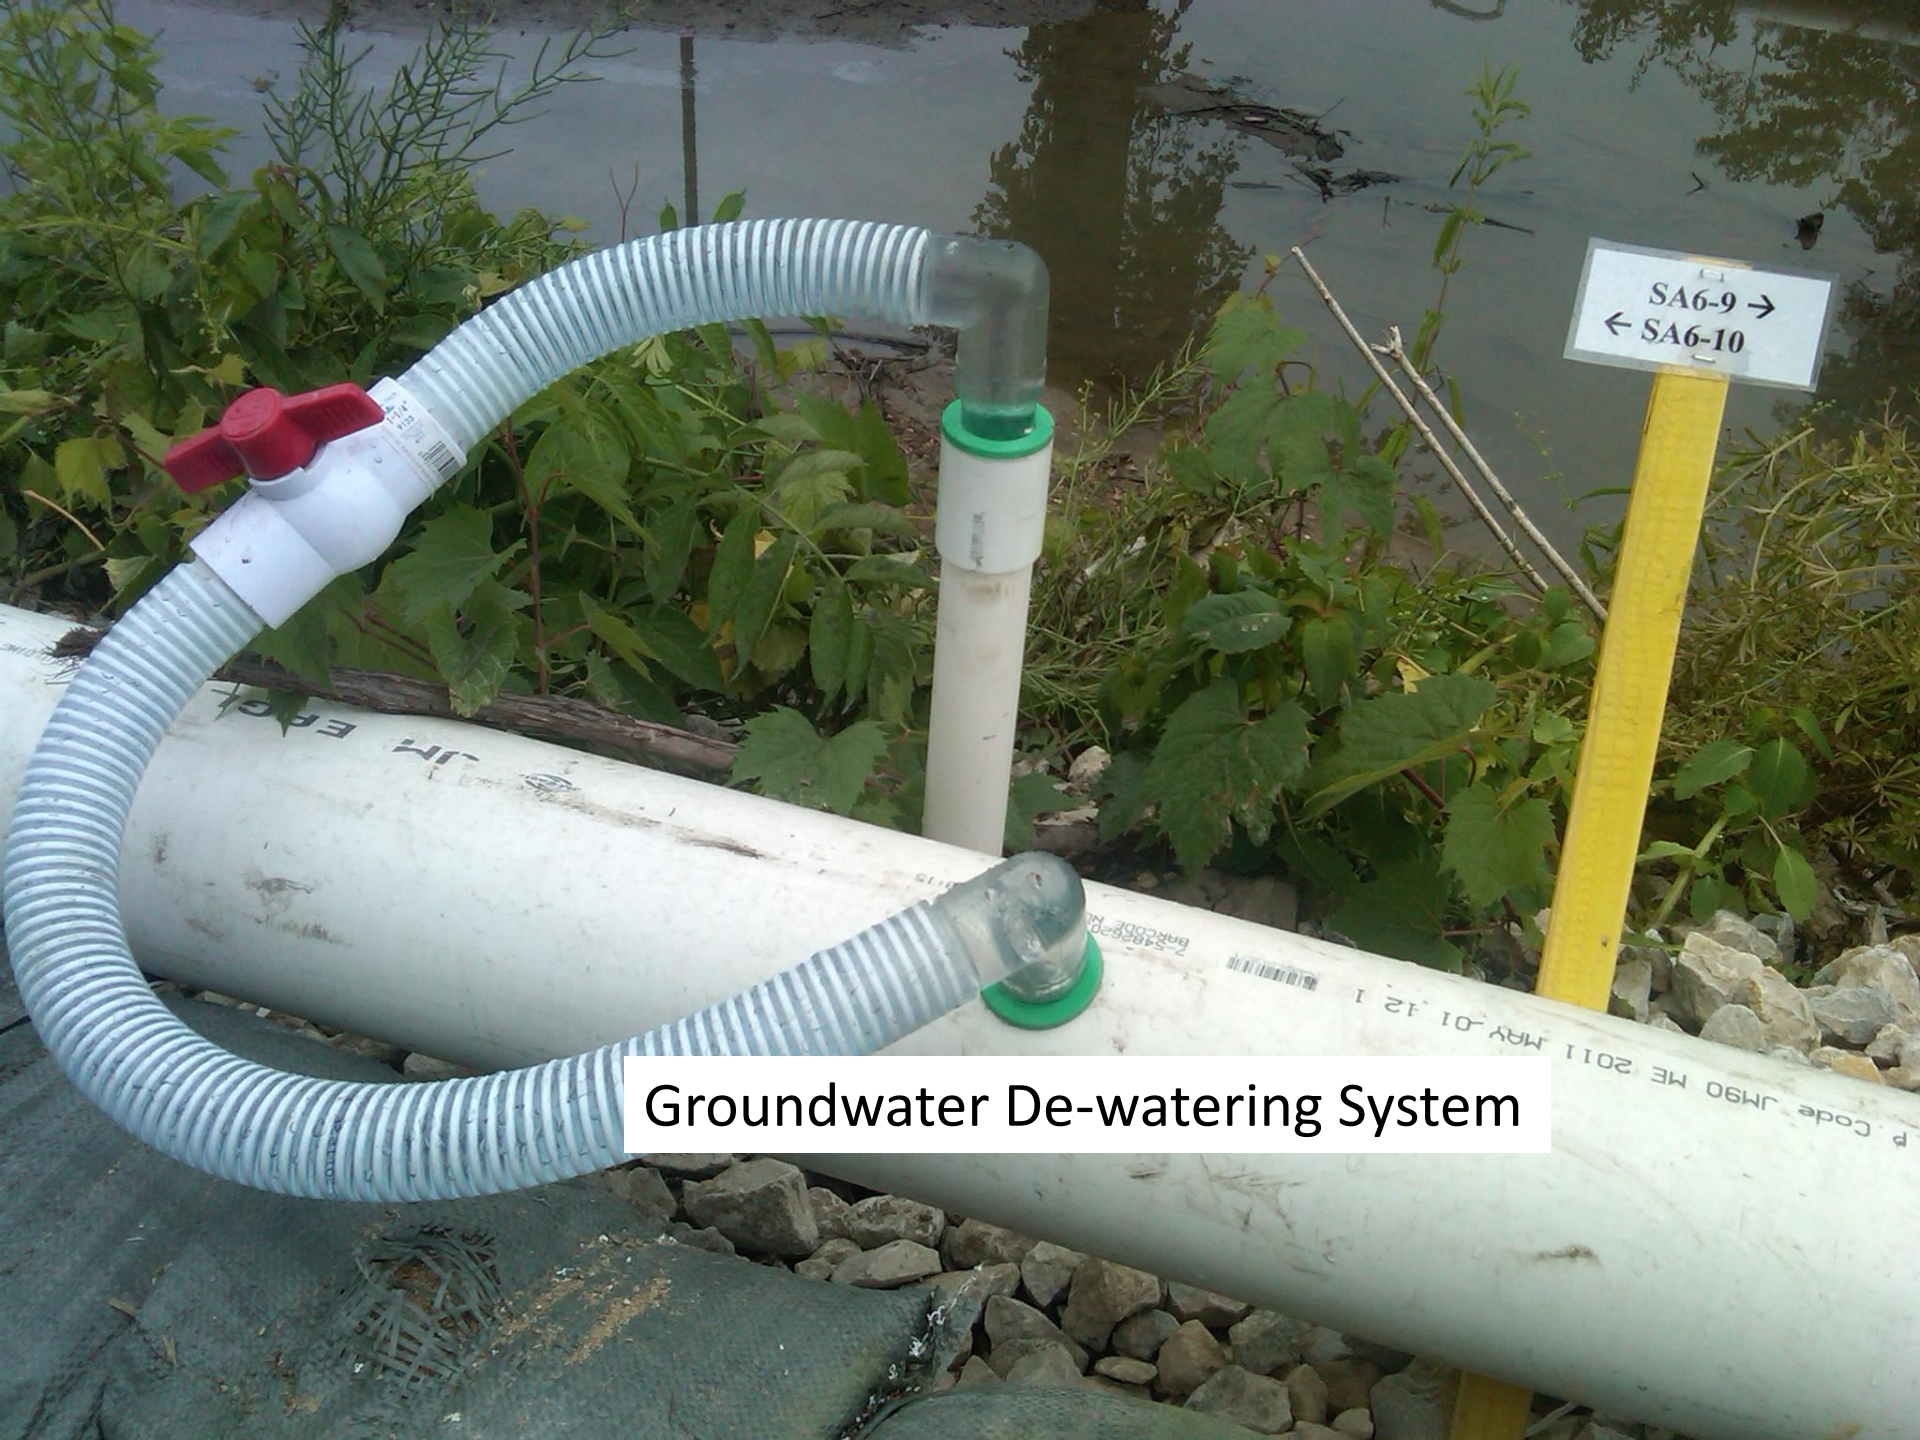
SA6-9 →
← SA6-10

Groundwater De-watering System

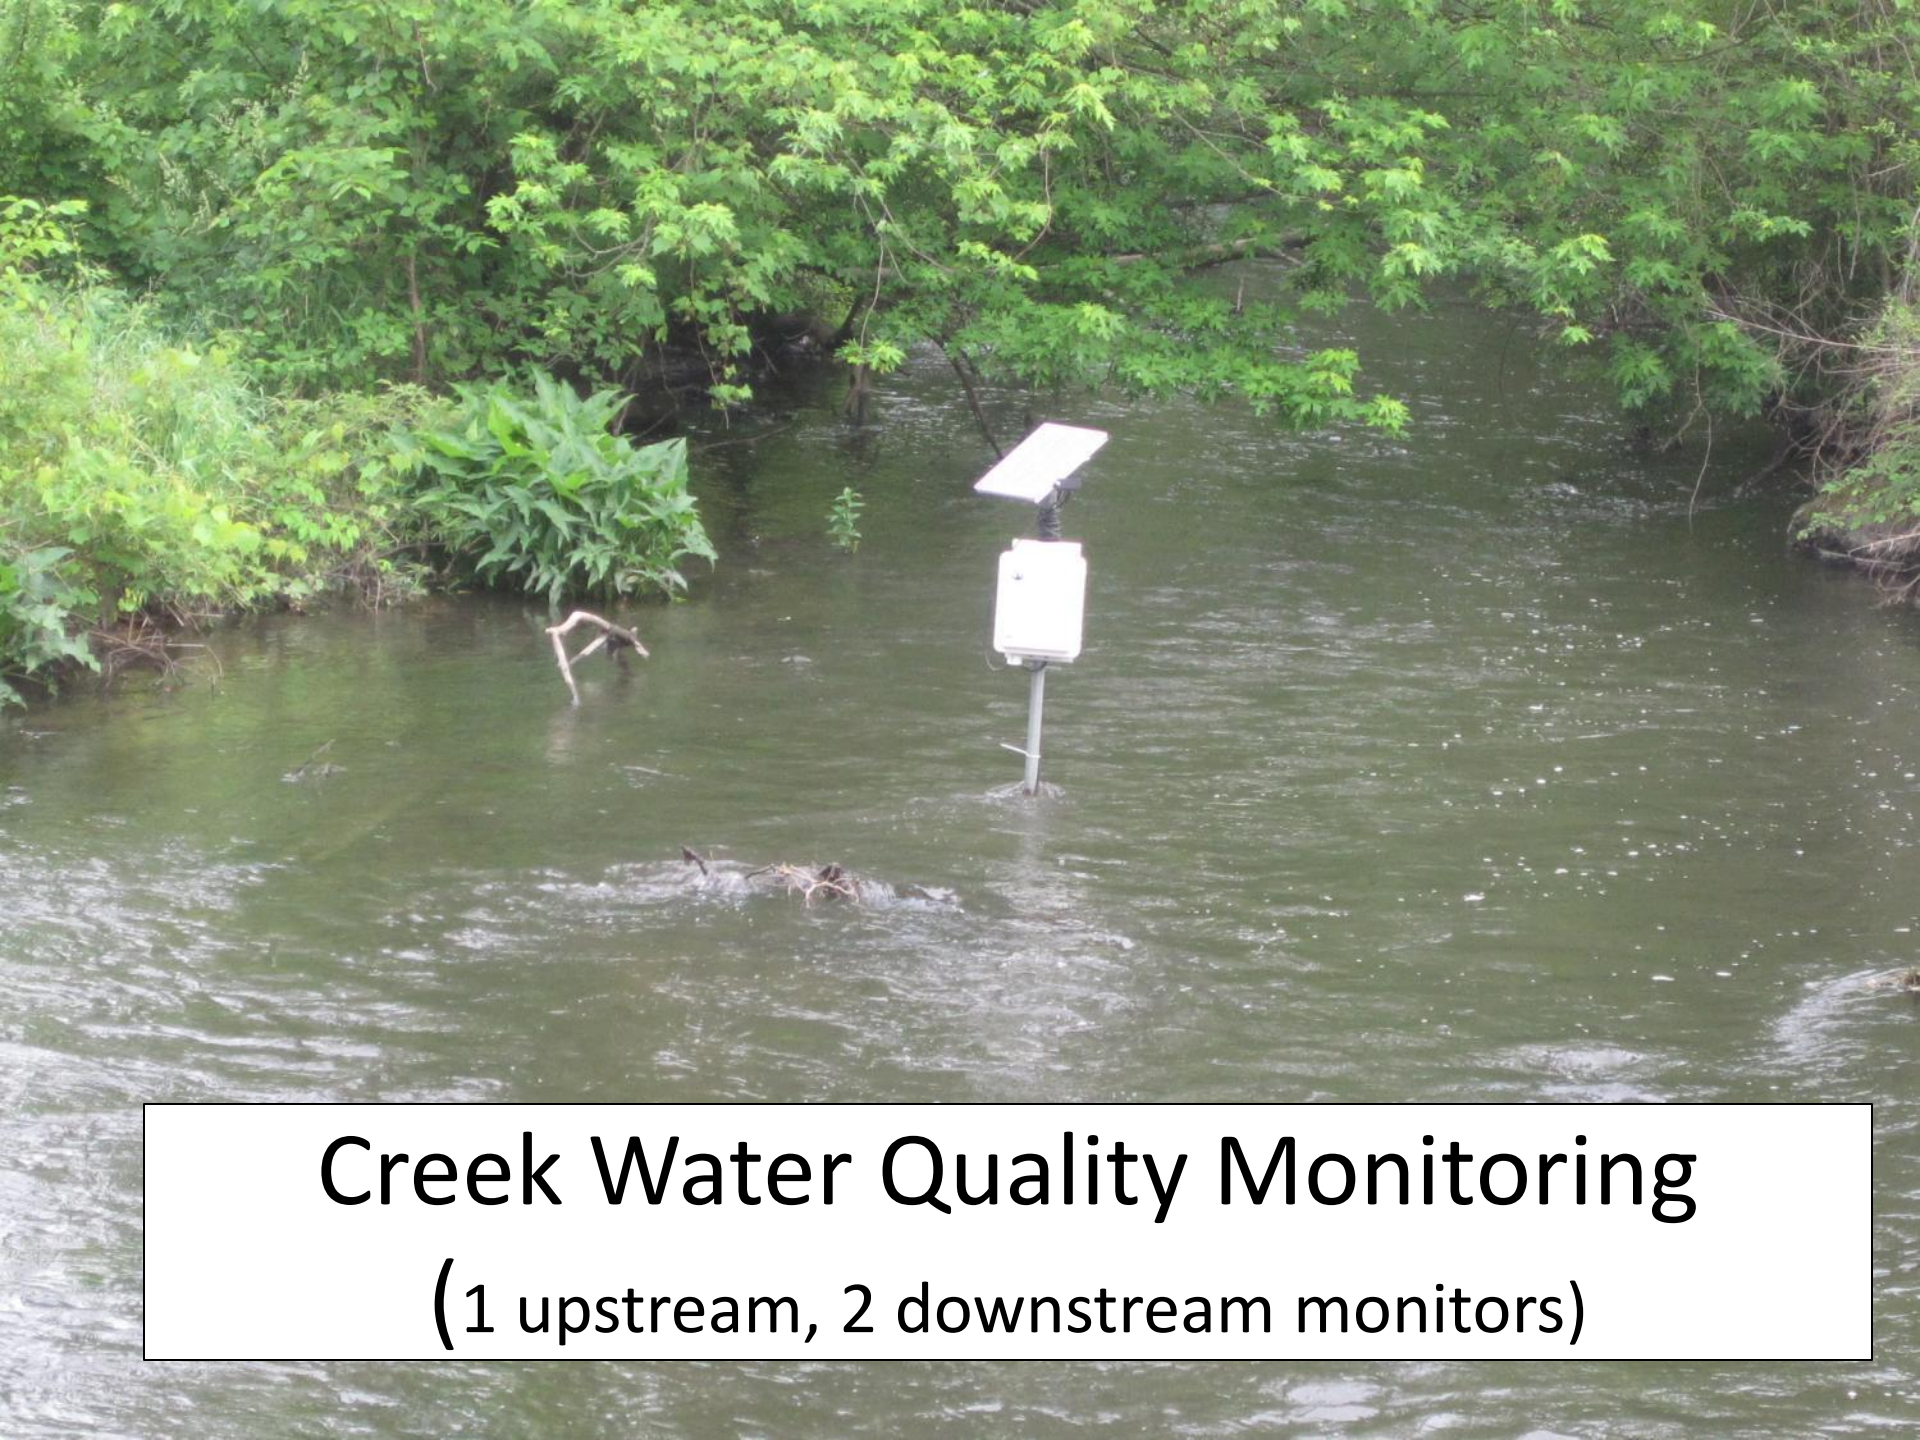
Creek Water Quality Monitoring

(1 upstream, 2 downstream monitors)

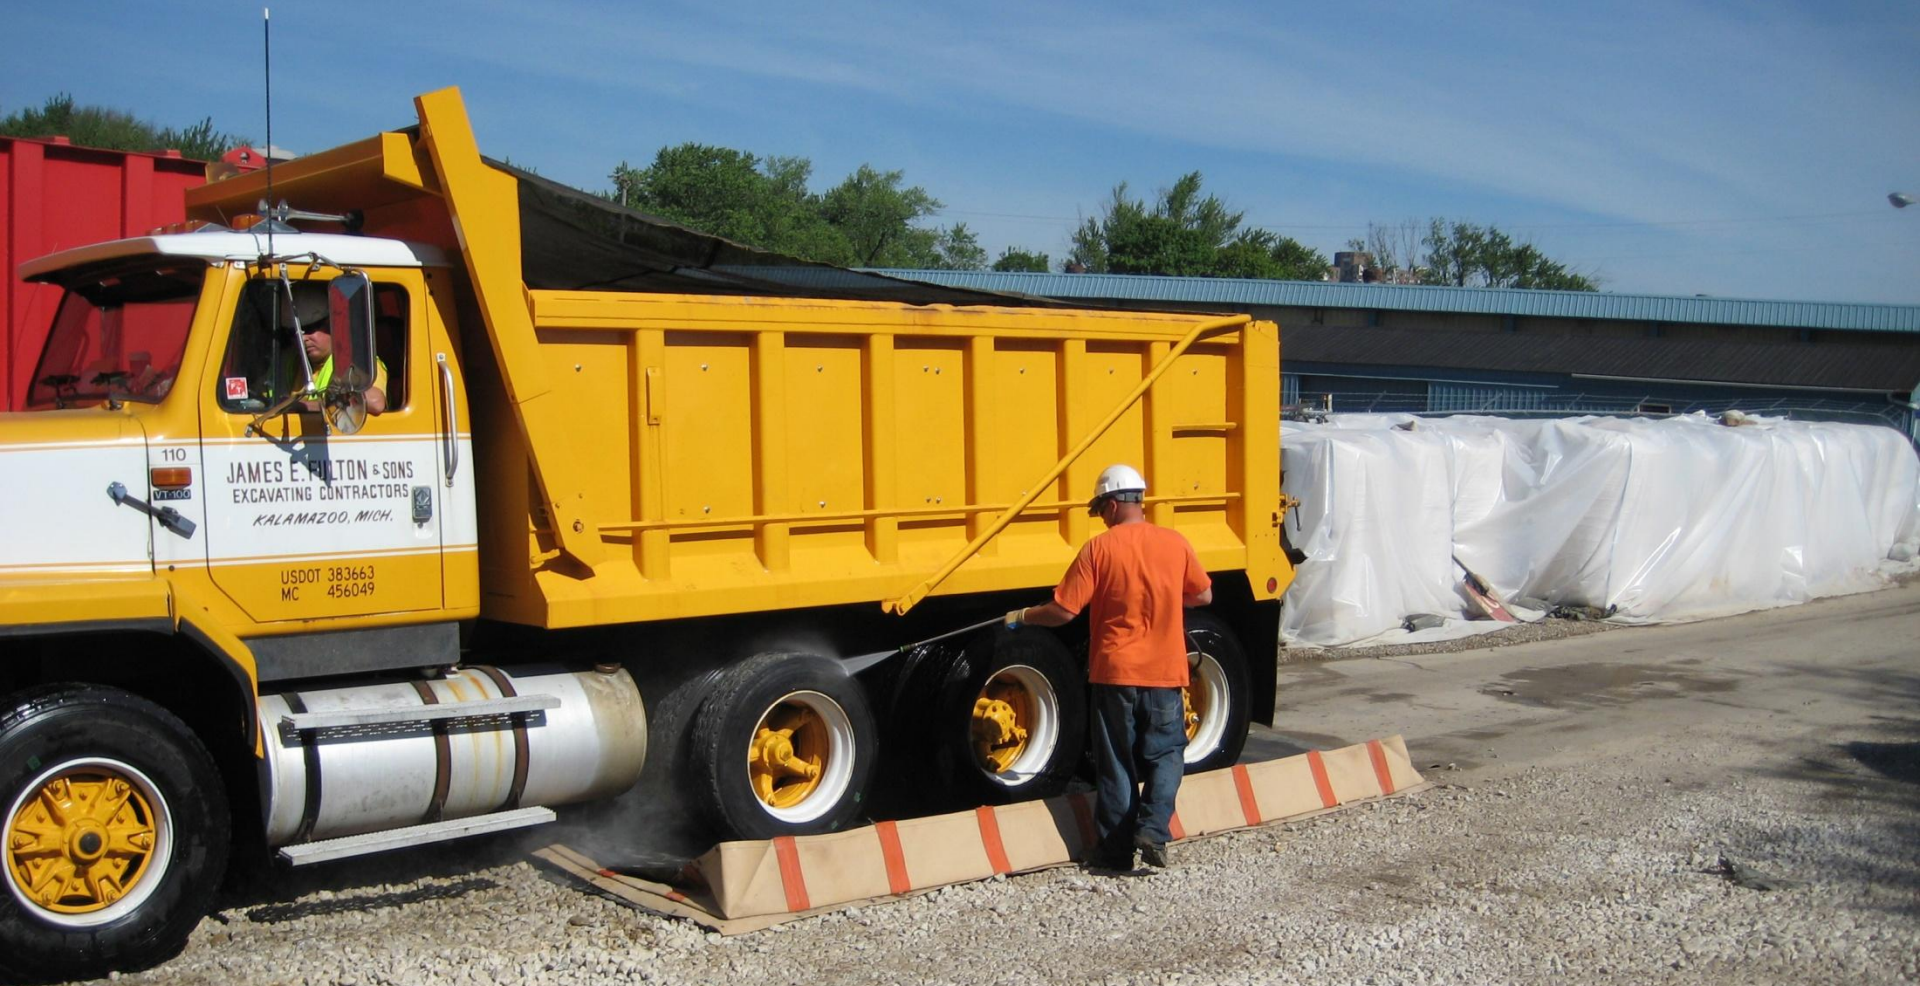
Truck tires washed before driving onto Stockbridge Ave.

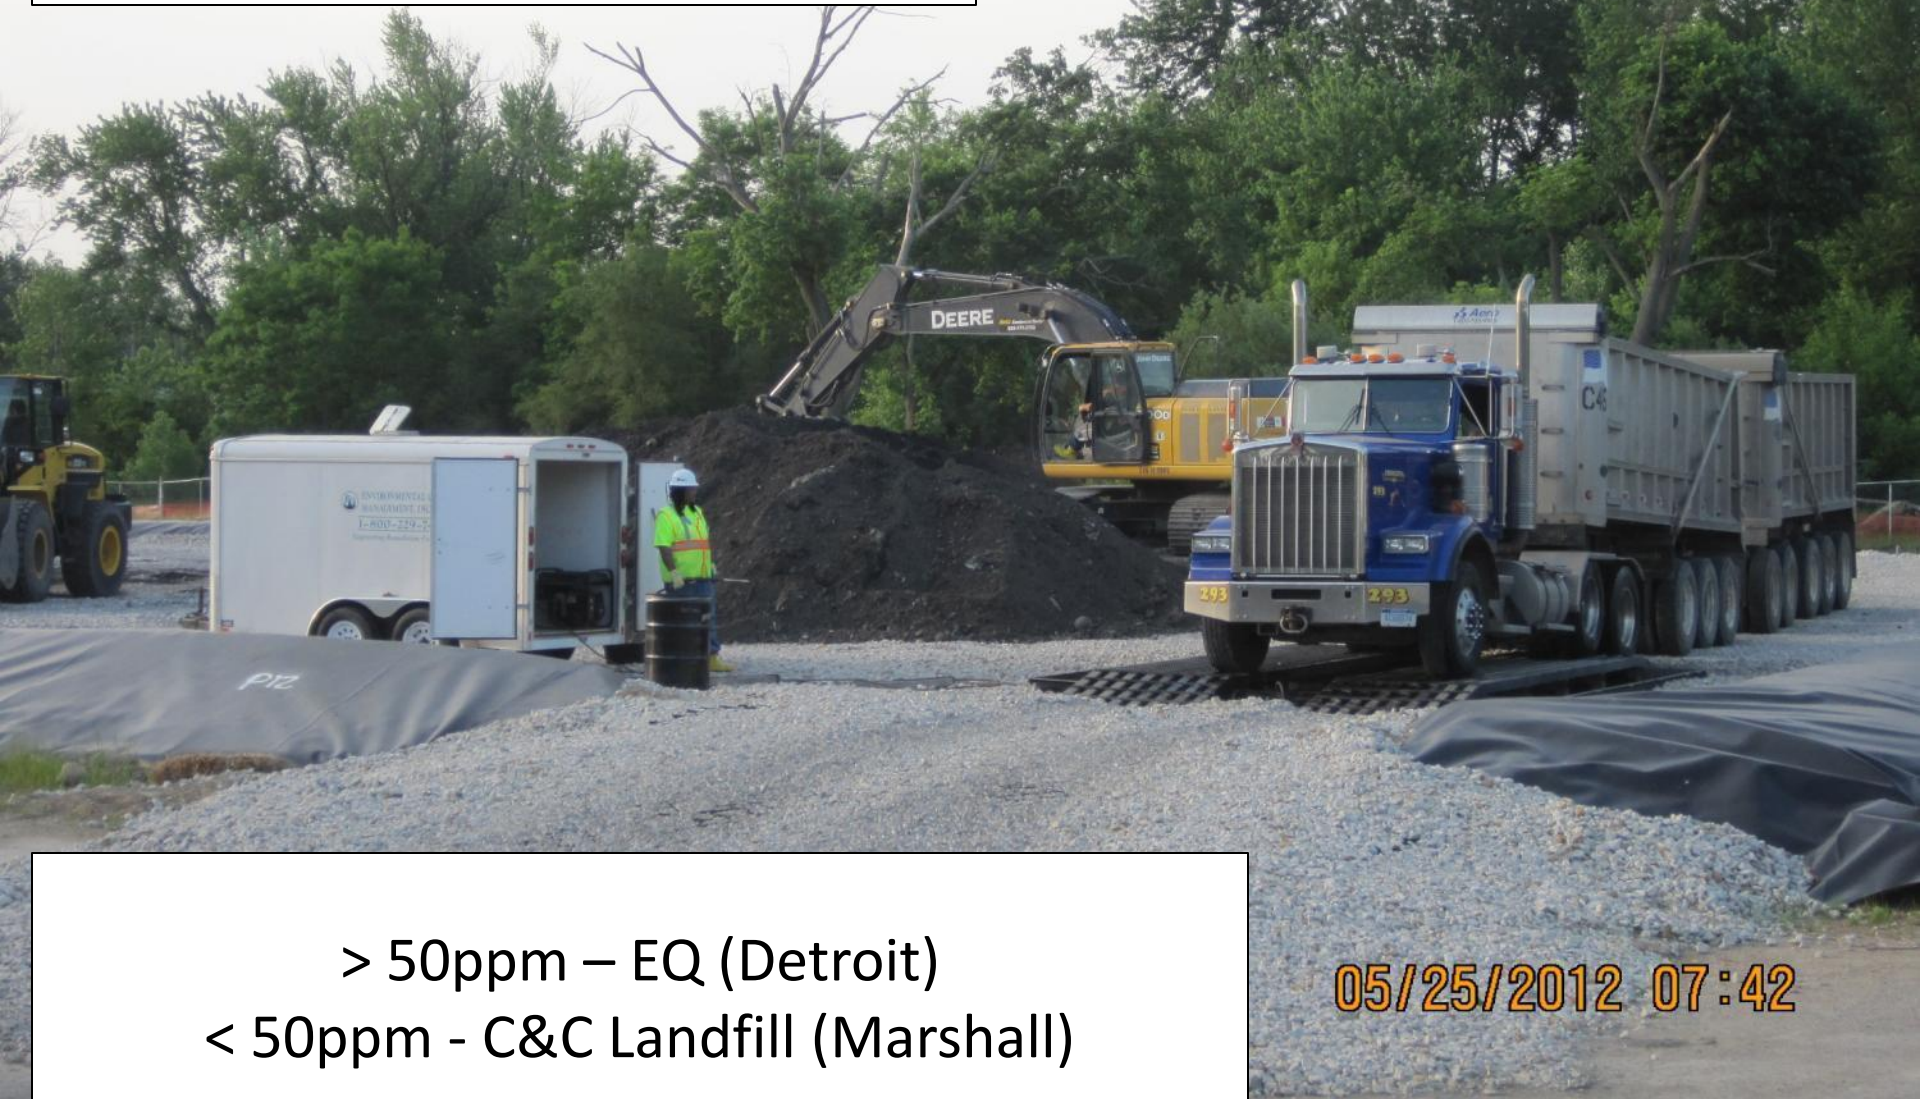
John Street Staging Pad

> 50ppm – EQ (Detroit)
< 50ppm - C&C Landfill (Marshall)

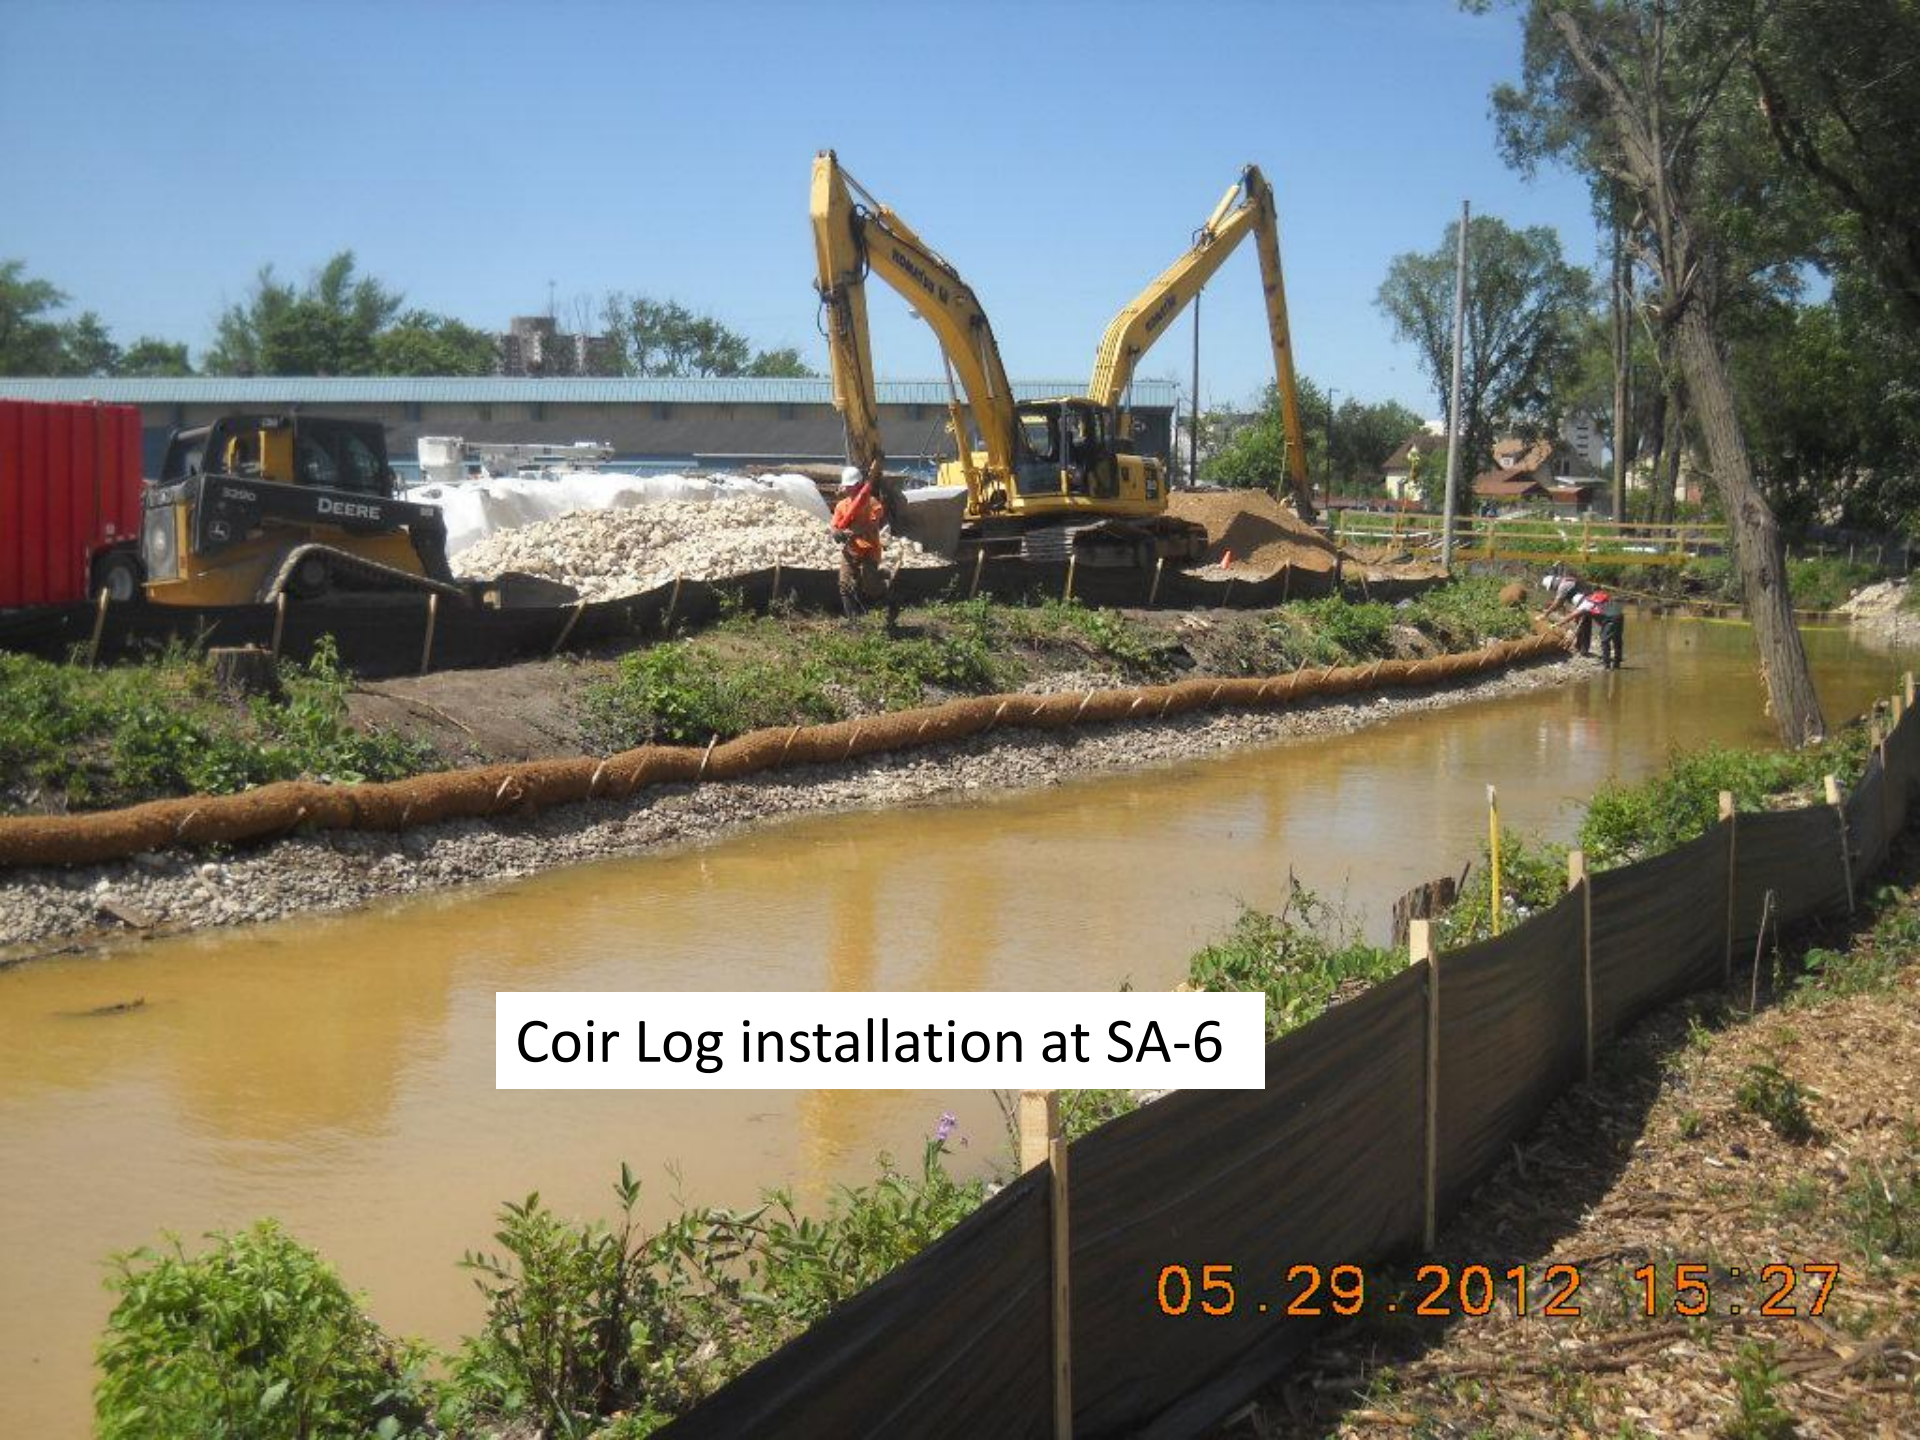
Coir Log installation at SA-6

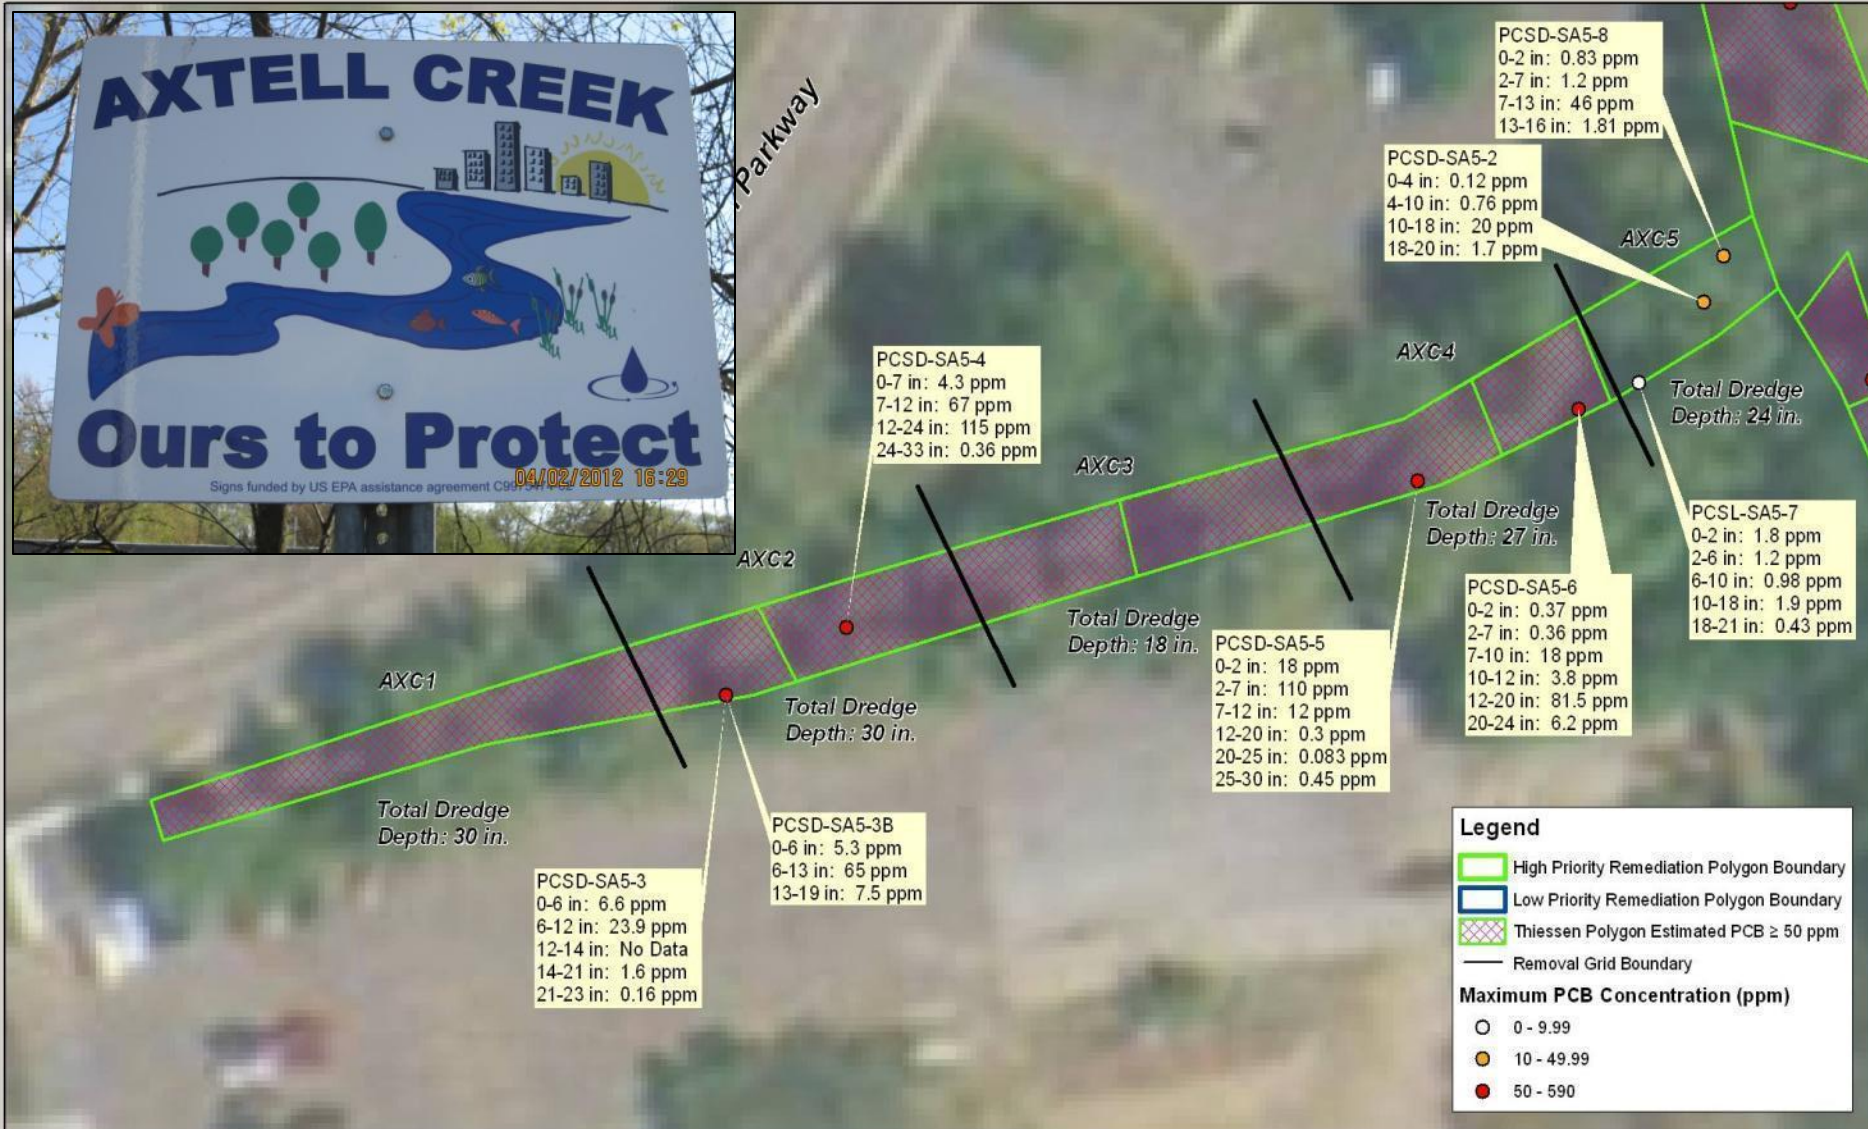
Portage Creek - Remediation Scenario (> 10 ppm): Axtell Creek
